**ALWAYS FIRST**  
**HOME INSPECTIONS**  
INTERNACHI CERTIFIED

# Home Inspection Report

1234 Main, Syracuse , UT 84075

Friday November 24, 2017

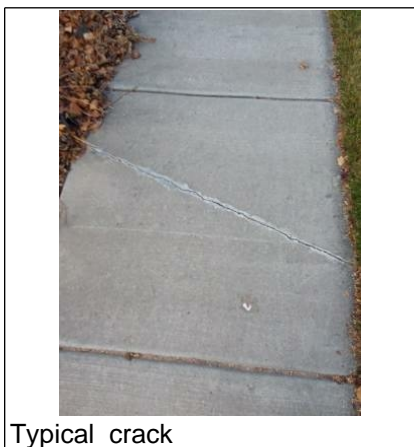
**Comments** Walkway had some cracking, but is usable. Recommend sealing crack.

Typical crack

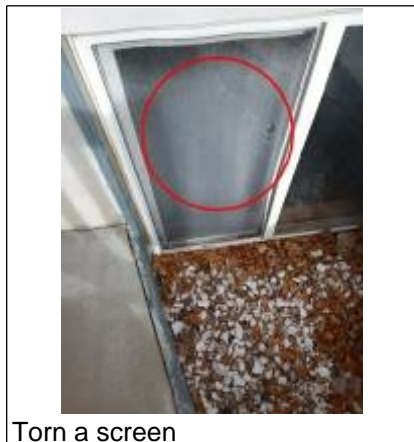
**Comments** Some screens not installed.  
Some screens are torn recommend repair

Torn a screen

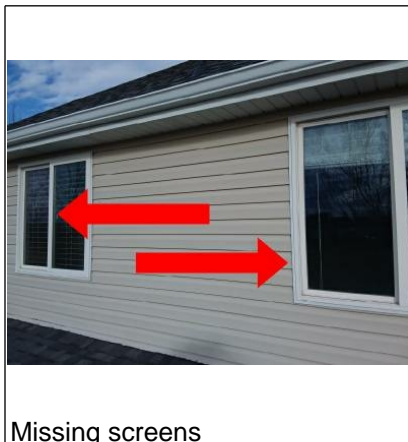
Missing screens

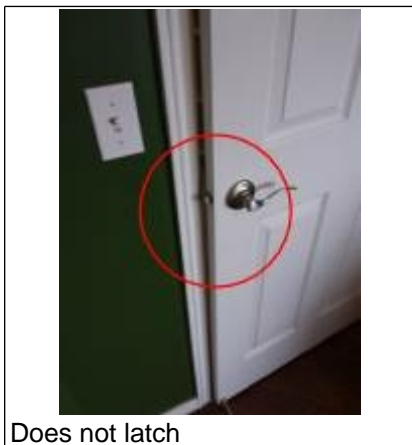
Does not latch

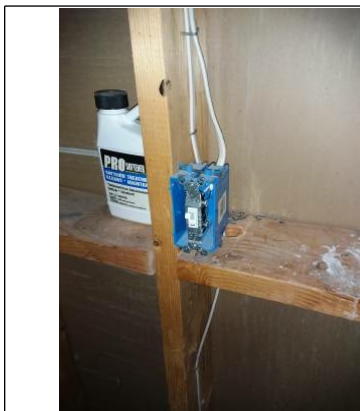
**Comments** Some open junction boxes and outlets were in need of covers.  
 Outlets were randomly tested and had correct polarity, except as noted.

Cover plate missing

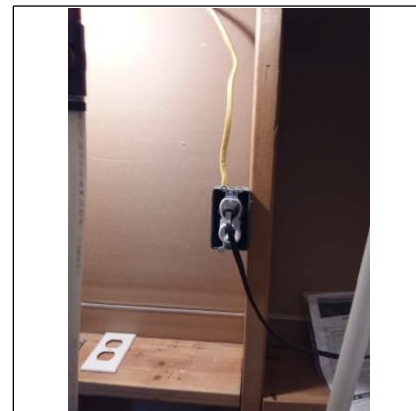
Outlet plate missing

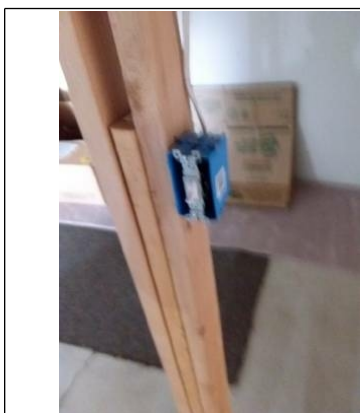
Missing plate cover

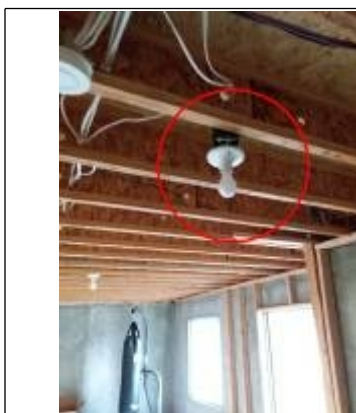
Exposed wires
